II. EXISTING MARINA FACILITIES

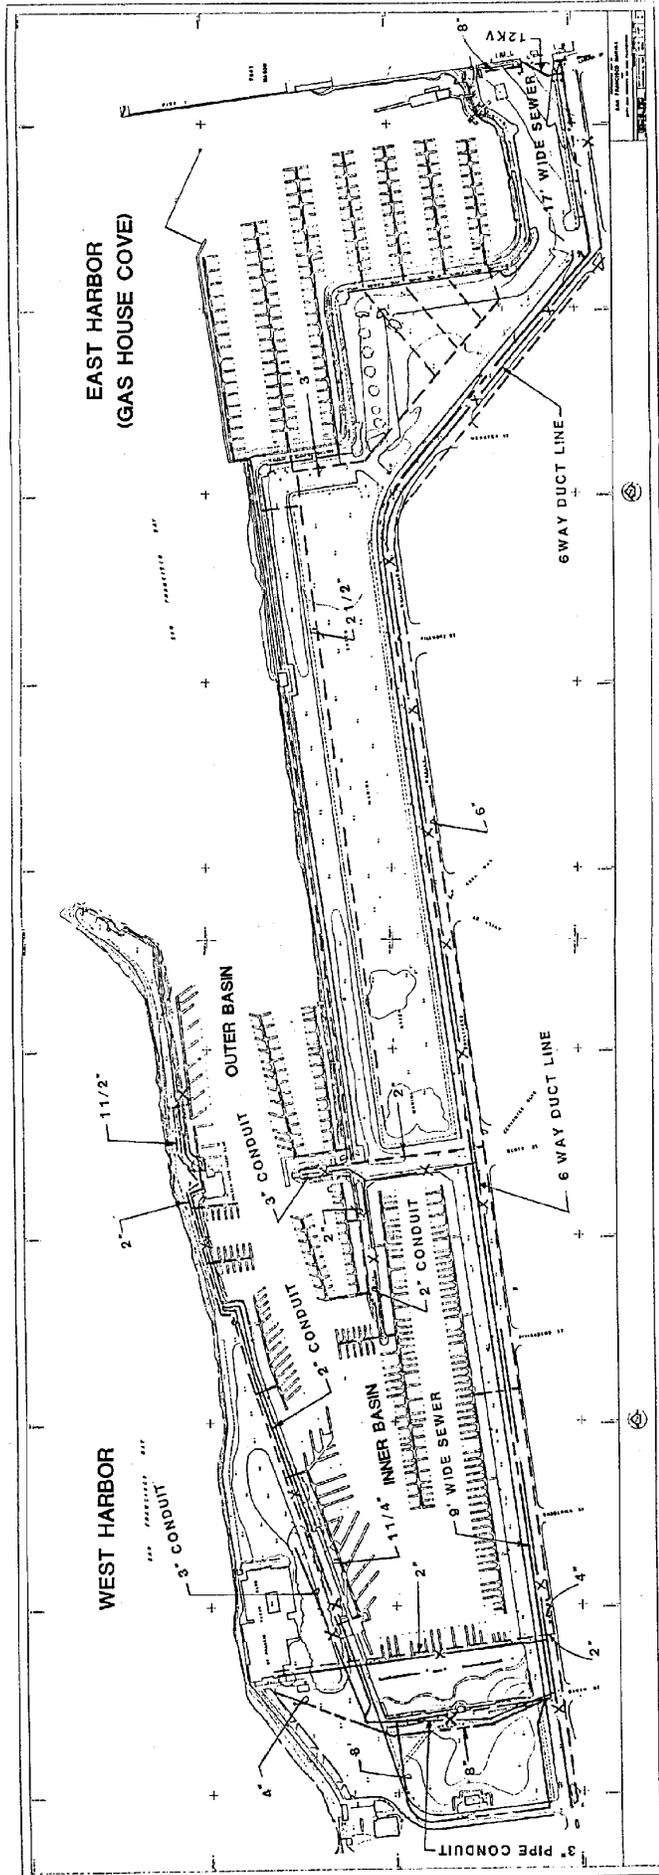
FIGURE 3: EXISTING CONDITIONS

The San Francisco Marina facilities have existed in their present configuration since 1963. The docks and gangways are made of timber and have degraded over time. Other Marina facilities, such as utilities, have become obsolete. The present configuration of the West and East Harbors is shown in Figure 3. The following paragraphs describe the existing condition of the facilities, with a focus on current deficiencies and areas where improvements are needed. The overall condition of the Marina was determined to be poor in a study by Snug Harbor Consultant (1991).
