3. CRITICAL AREAS OF EROSION

3.3 HIGH TO MODERATE RISK AND HIGH CONSEQUENCE AREAS

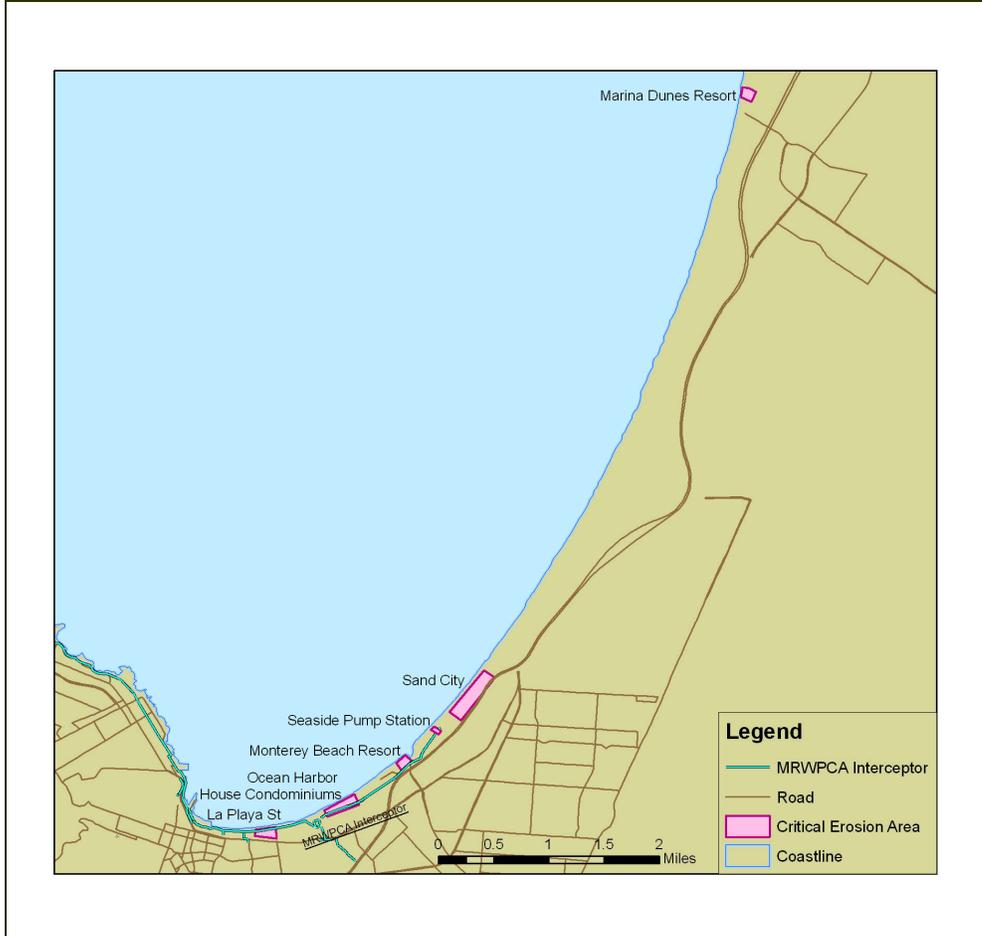
Figure 19. Location of Critical Areas of Erosion

The locations of high to moderate risk and high consequence critical areas of erosion are shown in Figure 19, summarized in Table 10, and described in detail in Section 3.3. They are also available as GIS data files in CSMWs GIS database.

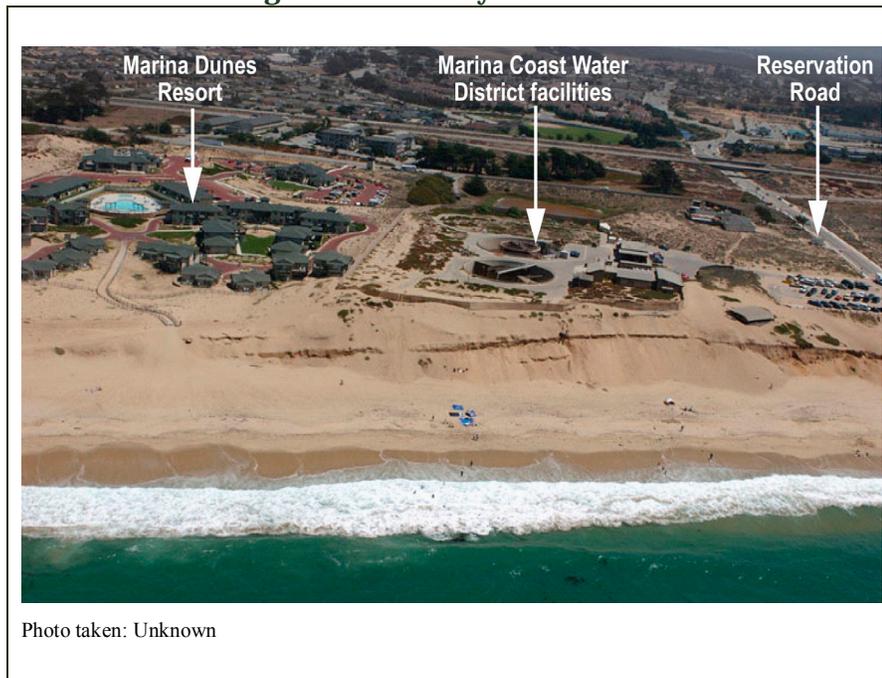
Figure 20. Sanctuary Beach Resort

The Sanctuary Beach Resort is located on a 17-acre site between Dunes Road and the coastal bluff fronted by 550 feet of shoreline (Figure 20). The development includes 112 vacation units, a 72-unit hotel, a conference center, retail facilities, a large restaurant, a health club, a recreational building, two tennis courts, a pool, playground and nearly 500 parking spaces. The resort was constructed in the mid 1990s on land formerly owned by the Monterey Sand Company. Because the dunes had been mined for sand for about 45 years (Table 4), the site lies at a lower elevation than adjacent dunes to the north and south. The resort contains buildings and paving on 6.5 acres, landscaping on four acres, and restored dune habitat on 6.5 acres. A boardwalk provides beach access across the southern portion of the dunes. The seaward-facing wall and buildings of the Sanctuary Beach Resort complex are set back approximately 120 feet from the top of the bluff (Figure 20).

The bluff at this location has eroded approximately 4.5 ft/year over the past 20-30 years (Table 4), and with relative sea-level rise is estimated to erode at approximately 5.5 ft/year over the next 50 years. The erosion rate has increased over the past 20 years (Table 3), which may be the result

of increased extraction of beach sand from the mine located only one mile north of the resort. Future dune erosion of 5.5 ft/year would mean that the Sanctuary Beach Resort would be compromised in approximately 20 years time and is therefore designated as a facility at high risk of erosion.

The loss of this facility would have high economic consequences to the region as it is a popular tourist destination. The loss of the dunes on this site would also impact endangered western snowy plover, and the black legless lizard (Section 4.2).

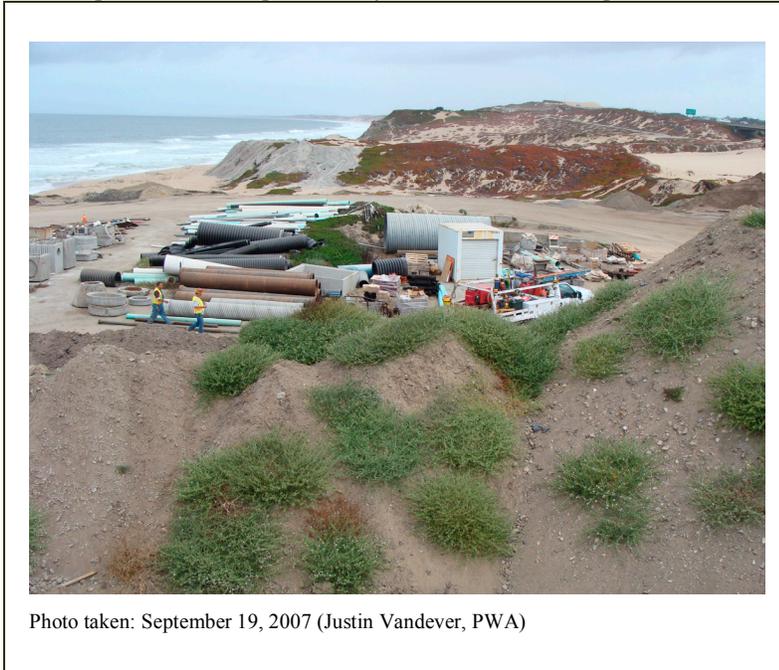
Figure 21. Storage Facility at the end of Tioga Avenue

Currently, remnants of a cement mixing facility are located immediately north of Tioga Avenue in Sand City. The facility is now used for temporary storage of construction equipment (Figure

21). Un-engineered structures are holding the shoreline seaward of its natural position creating a peninsula effect (Figure 6) and in the process they block lateral public access (creating safety hazards), prevent natural shoreline retreat, and beach area is lost both for recreation and as a habitat. Also, portions of Highway 1 curve seaward towards the dunes at Sand City. This section of the highway is approximately 400 feet from the dune edge and will ultimately be threatened by coastal erosion.

The future erosion rate of the unprotected dunes adjacent to the Sand City site is estimated to be approximately 3.5 ft/year. Continued loss of beach in front of the structures at Sand City will lead to further undermining, erosion, and eventually total failure. The existing storage facility and part of Tioga Avenue which provides access to the facility and the beach would be lost. The Tioga Avenue/Sand City complex is designated as a facility at high risk of erosion.

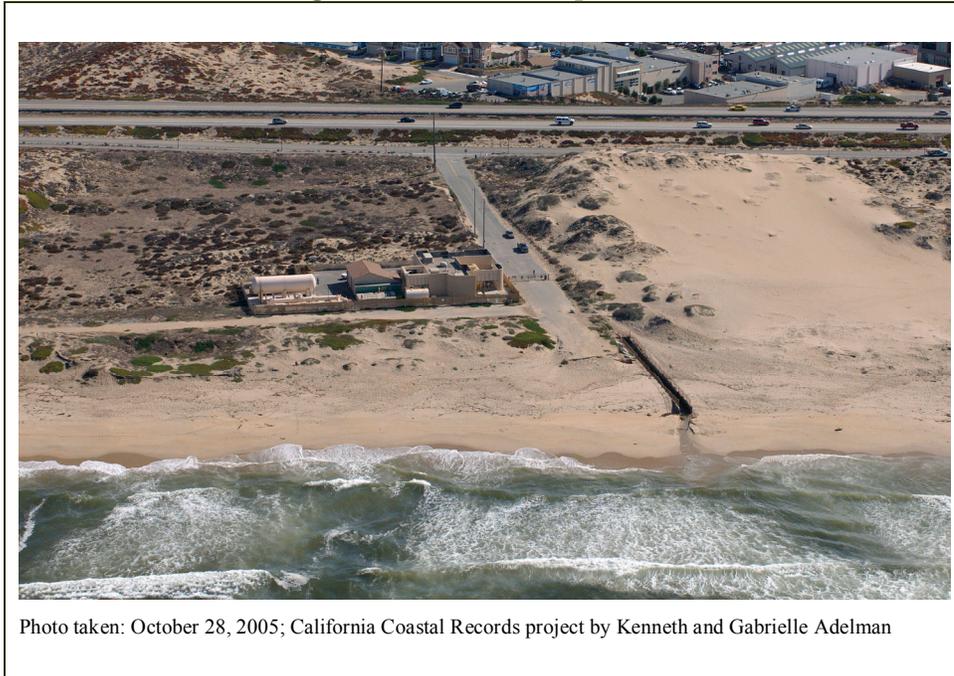
Figure 22. Seaside Pump Station

Seaside Pump Station (completed in 1983) is located at the junction of Bay Avenue and Vista del Mar Street. Seaside County Sanitation District’s former wastewater treatment plant was originally located adjacent to Seaside Pump Station. That plant was decommissioned in 1990 when a Regional Treatment Plant was completed north of Marina, and all of the treatment plant tanks and structures were demolished. The bulk of the site was sold to the California Department of Parks and Recreation (CDPR), although MRWPCA retains ownership of the Seaside Pump Station site. The Seaside Pump Station is approximately 100 feet from the base of the low-lying dunes that front the facility (Figure 22).

The historic rate of erosion has been approximately 2.5 ft/year, and the future rate is estimated at 3.0 ft/year. The facility could be compromised by erosion in about 30 years. However, the site would be vulnerable to significant wave damage and flooding before that time due to the low elevation of the fronting dunes. The top of the dunes are at approximately 25 ft NAVD compared to the base flood elevation (BFE – maximum elevation of wave runup and overtopping during a 100-year flood event) at this location of 27 ft NAVD (FEMA, 2007). Seaside Pump Station is considered a high erosion risk facility (PWA and Griggs, 2004).

Seaside Pump Station pumps all of the raw (untreated) wastewater from the cities of Pacific Grove, Monterey, Del Rey Oaks, Seaside, and Sand City through the regional wastewater system to the MRWPCA Regional Treatment Plant. The pumps are a key component of the system and need to remain in full operation indefinitely, so erosion would have significant economic, environmental, and human health impacts. A breach of this facility would have environmental impacts to the dunes and beaches, and water quality impacts within the MBNMS. Seaside Pump Station is therefore designated as a high consequence facility.

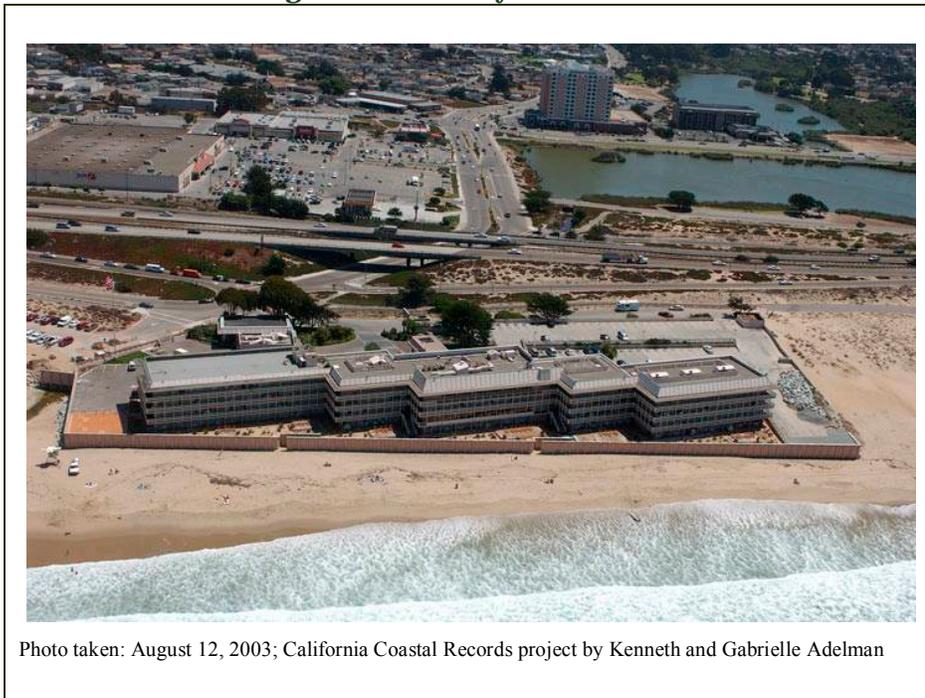
Figure 23. Monterey Beach Resort

The 196-room Monterey Beach Resort hotel was constructed on north Del Monte Beach in 1968 and consists of five four-story buildings, a restaurant, meeting rooms, a pool, and parking structures (Figures 5 and 23). It was originally constructed with surrounding seawalls and a large beach area fronting the hotel. This part of Del Monte Beach was a major attraction of the hotel. Since the hotel was built, shoreline erosion has occurred up coast and down coast, and the hotel has become a headland.

Here future erosion rates are estimated to be approximately 1.5 ft/year. When the existing seawall was built in 1968, beach elevations in front of the hotel were over three feet higher than today. Erosion has lowered the beach elevations such that during high tides there is now no beach access

in front of the hotel. The existing seawall is not embedded deep enough into the sand to withstand further beach erosion. This structure was partially breached during the severe El Niño winter of 1983 when large waves coincident with very high tides surged through the stairwell opening in the wall, broke through the joints in the wall causing loss of fill behind. In 2004, much of the south wing wall of the seawall failed with collapse of the fill behind the wall. Emergency riprap was brought in to fill this void (Figures 5 and 23). Because of the erosion problem the hotel has received approval from the Coastal Commission to build a new seawall. The seawall has not yet (June 2008) been constructed. It would comprise a 600-foot long driven sheet-pile metal seawall with a footprint of 1,000 square feet immediately adjacent to the existing seawall. The permitted project would also involve removal of the existing end walls and replacement with driven sheet-pile walls.

In addition to the Resort, the access road on Sand Dunes Drive and the offramp to Highway 1 are within the 50-year erosion zone. The Monterey Beach Resort and the road infrastructure are designated as facilities at high risk of erosion.

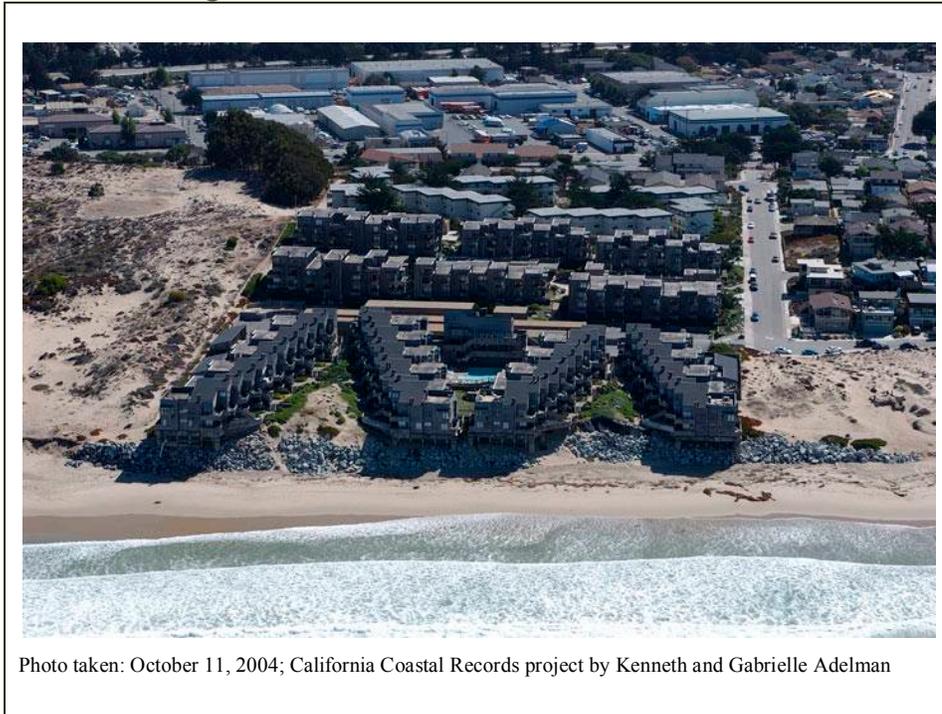
Figure 24. Ocean Harbor House Condominiums

Beginning in 1968 the first eight buildings (Ocean House) of an apartment complex were constructed on the dunes on Surf Way in Monterey. An additional six buildings (Harbor House) were constructed further landward in 1974. At the time of construction, the City of Monterey allowed the front buildings to overhang the utility easement running parallel to the bay in return for all land seaward of the easement, which means the City owns all land up to the edge of the front buildings. Collectively, the 172 units, now converted to condominiums, are called Ocean Harbor House (Figures 5 and 24).

Since its construction, Ocean Harbor House has had a history of erosion problems. Following the 1982-83 El Niño, erosion of the dunes had approached to within 14 feet of the shallow pilings supporting the complex (the bases of the pilings were at an elevation ten feet above MLLW). Emergency riprap (600 feet of rock over 20 feet high) was placed on Del Monte Beach to provide protection to the buildings but subsequently had to be removed, following completion of an Environmental Impact Report (EIR) in 1984, because of City of Monterey regulations regarding placement of materials on a public beach. The front pilings were subsequently removed and 50-55 foot deep concrete caissons were then poured along with grade beams to support the front row of condominiums. Despite the deep caissons and grade beams, waves continued to erode the dune face back beyond the two rows of caissons (Figure 5, right panel). Additional emergency riprap was required to protect the condominium units in 2002 and another EIR was completed to assess a number of longer-term alternatives to the riprap. While the preferred alternative was to remove the frontal units, the owners of the condominiums preferred to build a seawall to protect their property. The application was approved by the Monterey City Planning Commission, the Monterey City Council, and the Coastal Commission, with substantial mitigation fees involving nourishing the beach in front of the seawall. The seawall will be within the footprint of the existing building foundations, and will not encroach onto the City of Monterey (Del Monte Beach) property.

A new seawall fronting Ocean Harbor House is being engineered to withstand storm wave-attack and is considered a long-term (50-year planning) solution to erosion of the condominiums. However, it is likely that the new seawall will cause the fronting beach to further lower in elevation because the armoring will provide a surface for wave reflection. The seawall will also enhance the peninsula effect at this location, with the dunes to the east and west continuing to erode. Because of the seaward position of Ocean Harbor House and the limited set back of the Tide Avenue community, the condominiums and the Del Monte Beach subdivision are designated as facilities at high risk of erosion.

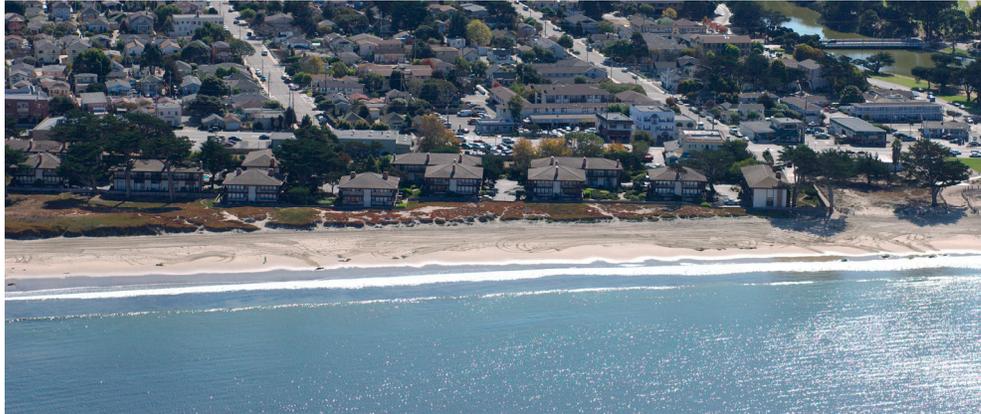
Figure 25. Monterey La Playa Town Homes

The La Playa town homes are located in the dunes at the end of La Playa Street in Monterey, and were originally constructed as apartments in 1964. The development was later converted to condominiums (Figure 25).

The westernmost condominium sits only 30 feet from the dune edge and is protected by a small pile of riprap, with most of the remaining complex over 50 feet from the shoreline. Long-term erosion rates are likely to be greater than 1.0 ft/year, and therefore structures towards the western end of the complex are at high risk of erosion over the next 50 years. In addition, the structures could be vulnerable to wave damage and flooding due to the low elevation of the fronting dunes, compared to the base flood elevation (BFE – maximum elevation of wave runup and overtopping during a 100-year flood event) at this location of 22-26 ft NAVD (FEMA, 2007).
