Chapter 10 Morphodynamic fingerprints.

1. The morphological fingerprint of the PEM-system.

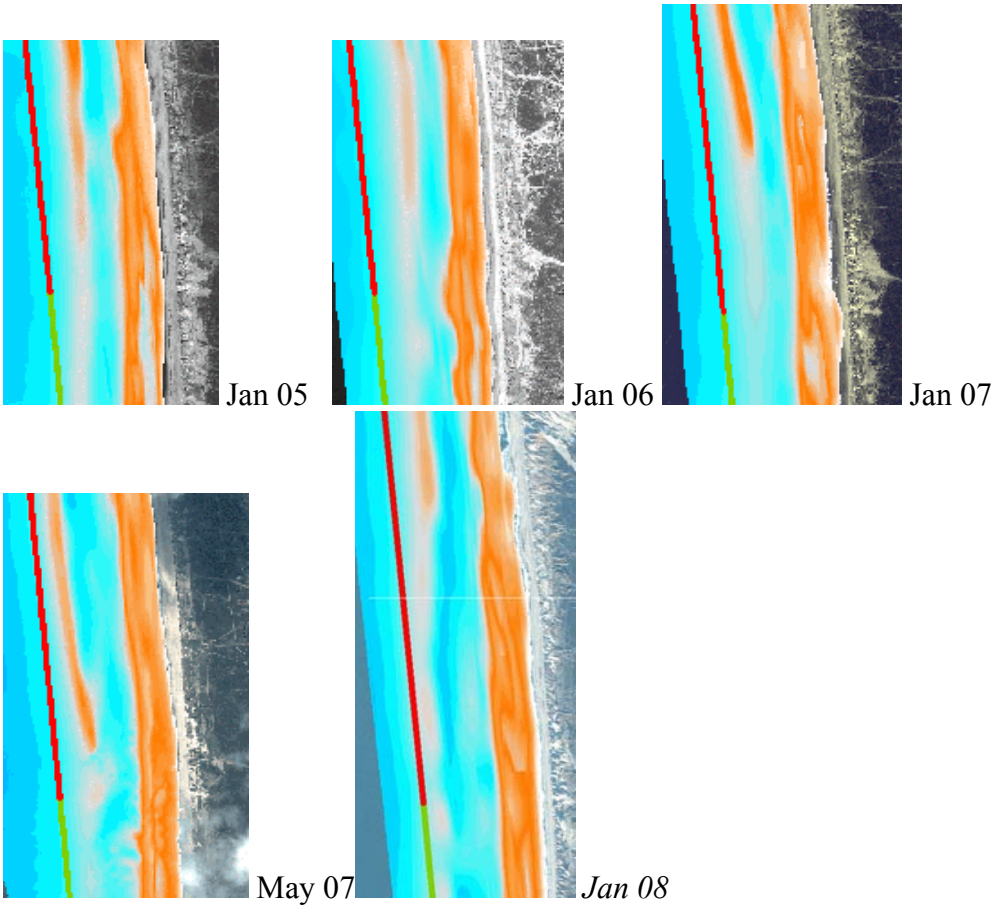
It is further observed from figure 11.12 that the bar generally expands in the Southern (down drift) direction, but fluctuates a lot. This can be one reason for the expansion of the narrow beach to a wider area during the test.

Figure 11.12: Snapshots of the bar behavior in the transition in between rør 1 and ref 2, based on figure 9.6.

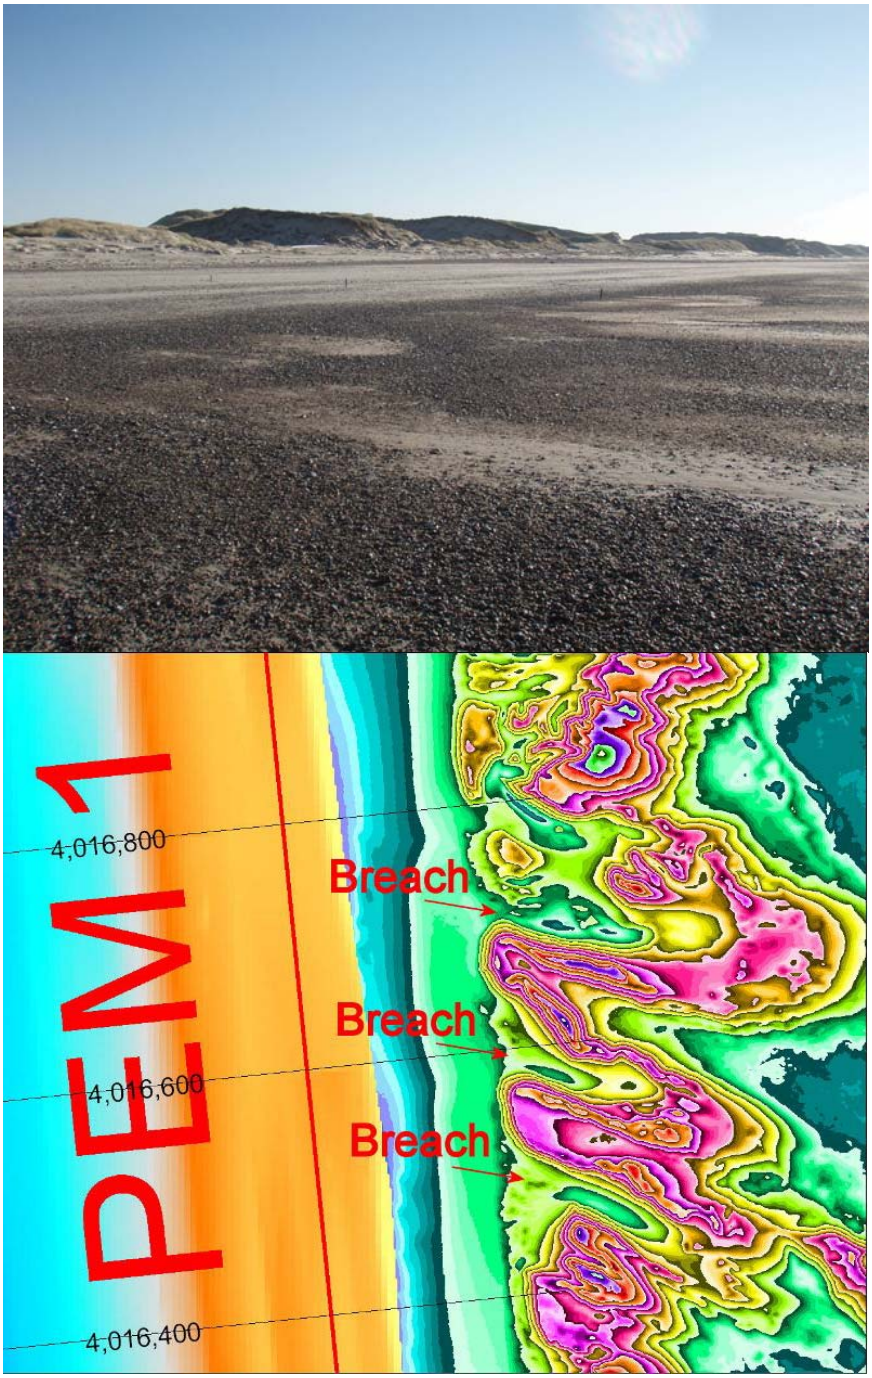
Figure 11.14: Mature breaches in the dune in the middle of Rør 1. (Note the tubes in the photo).

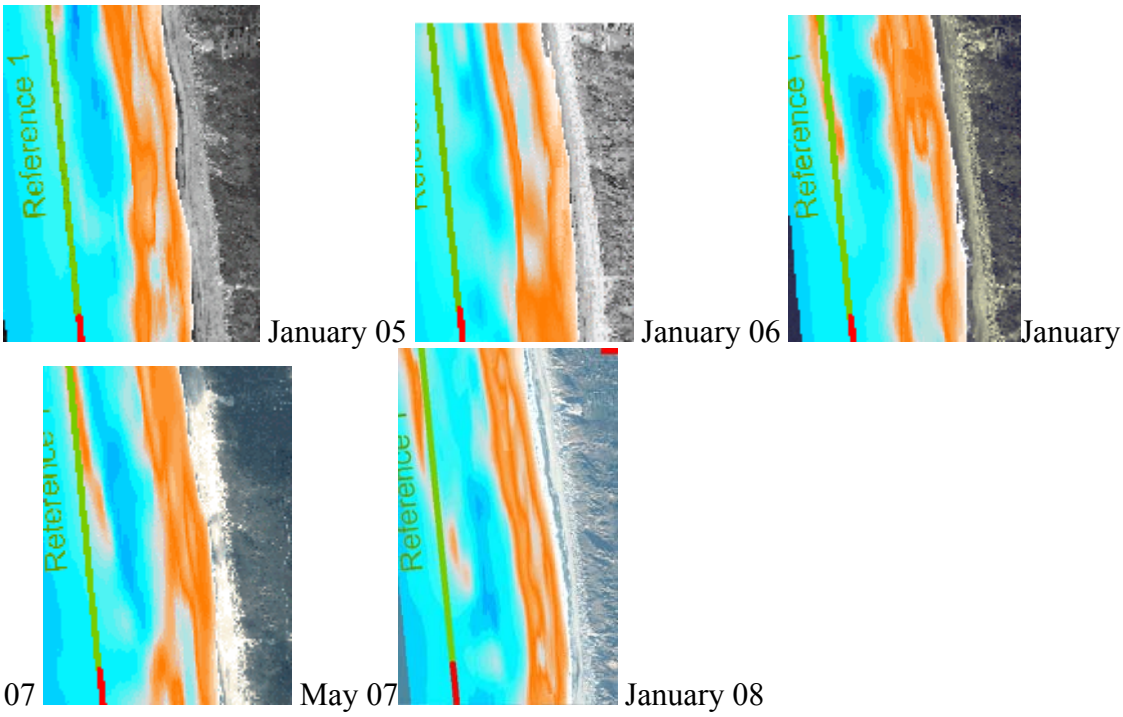
Figure 11.18: Bar behaviour in ref 1.

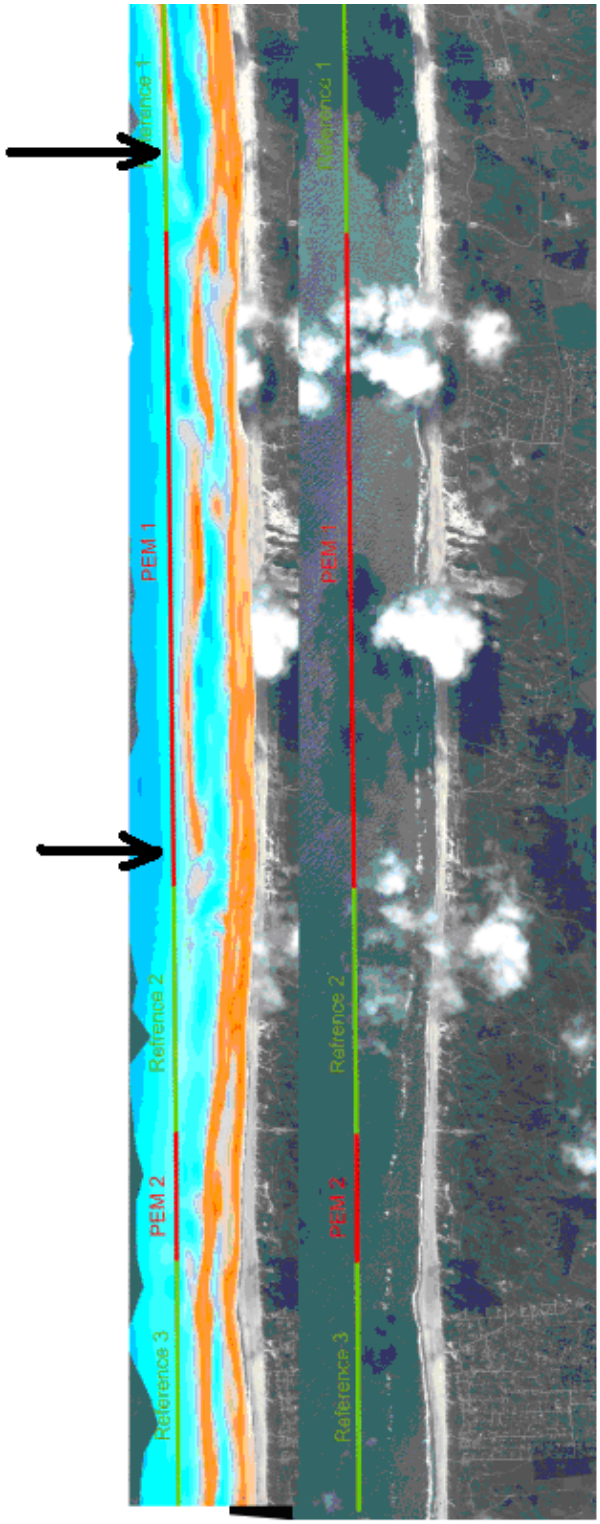
Figure 12.4. The outer bars terminate just up drift of the location of the transitions.
